# Aviation Investigation Final Report

| <b>Location:</b> | Windsor Locks, Connecticut | <b>Accident Number:</b> | ERA23LA135 |
| <b>Date &amp; Time:</b> | March 3, 2023, 16:00 Local | <b>Registration:</b> | N300ER |
| <b>Aircraft:</b> | BOMBARDIER INC BD-100-1A10 | <b>Aircraft Damage:</b> | Minor |

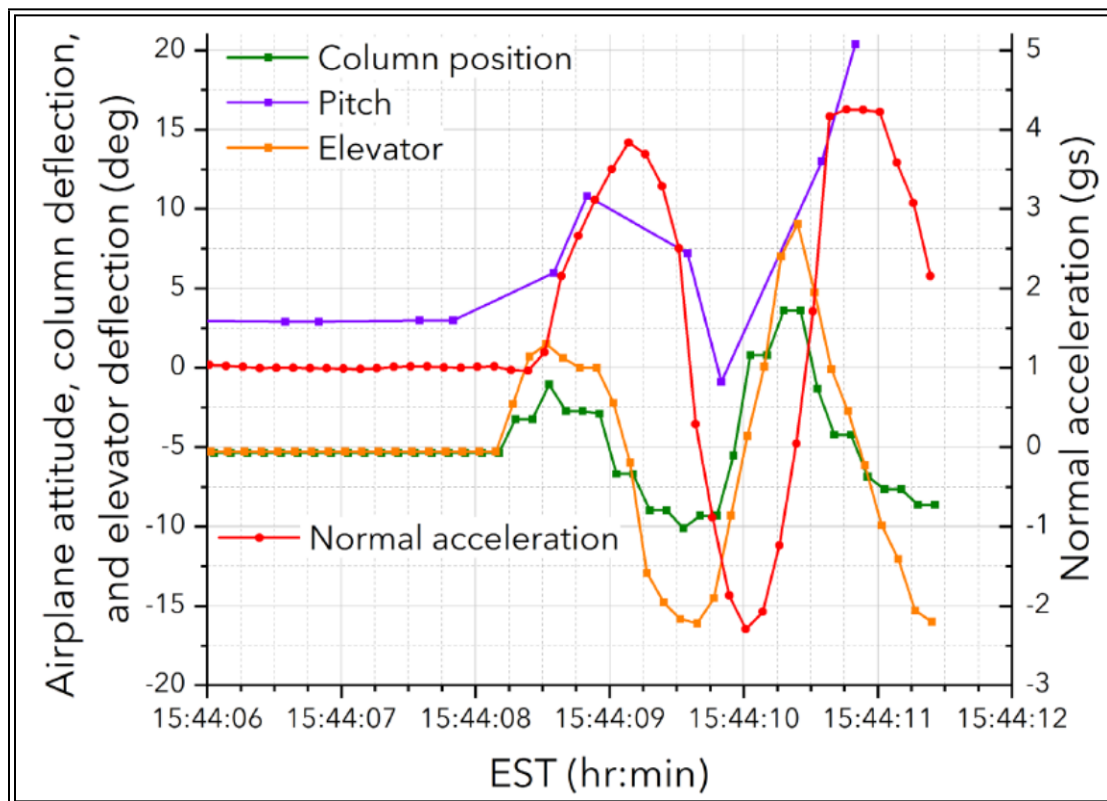
The study found that before the autopilot disengagement, the autopilot was holding an elevator deflection of 5.3° airplane nose-down to balance the airplane's pitching moments and acceleration due to the nose-up horizontal stabilizer position. Following the autopilot disengagement, the elevators rapidly moved to neutral, and the airplane, which had been in a 3° nose-up pitch attitude, rapidly increased pitch to 11° nose-up in one second, and the normal acceleration increased to 4g. The control column was subsequently pushed forward by the PIC with at least 90 lbs of force, the airplane pitched down to a near nose-level attitude, and the normal acceleration was reduced to -2.3g. The control column was then pulled back through neutral, and the airplane again rapidly pitched to over 20° nose up and more than 4g of normal

acceleration. The FDR then stopped recording, as the inertial g switch was triggered by the loading. As a result, the full extent of the pitch event was not recorded. Figure 1 provides an overview of the airplane pitch, column position, and elevator deflection, versus time and normal acceleration for the event. The dots on each respective line trace each sample of the FDR channel.

Figure 1: Airplane pitch, column position, and elevator deflection versus time and normal acceleration for event. The dots on each trace show each sample of the FDR channel.

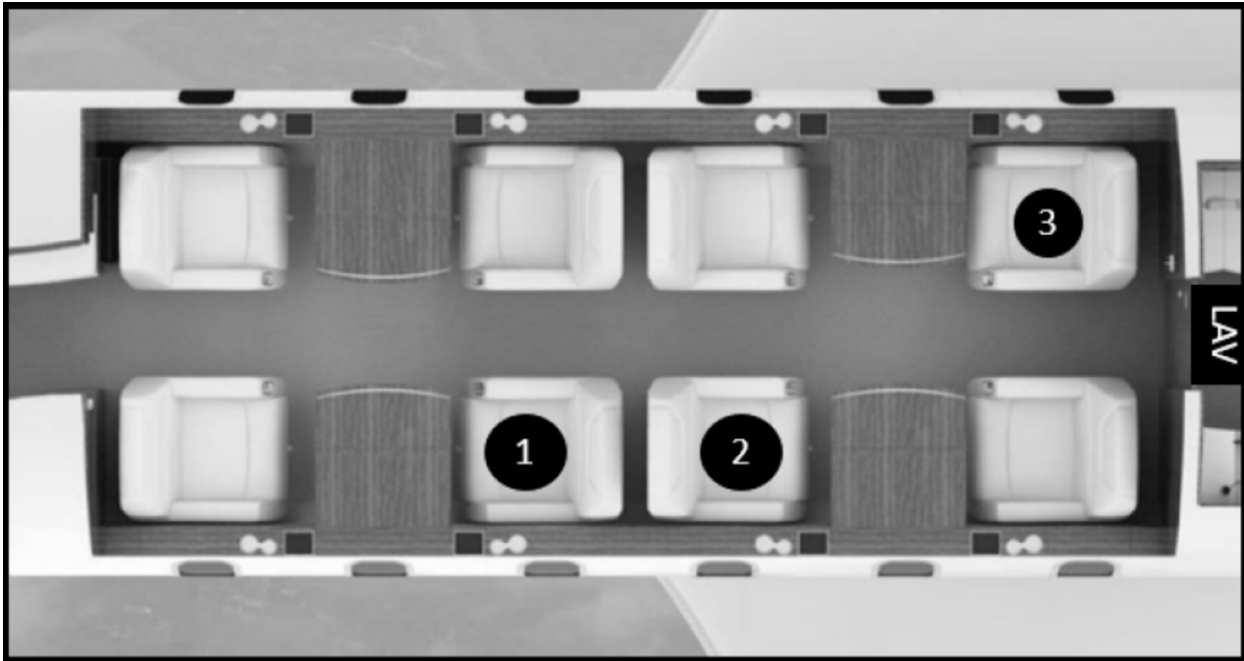
Figure 2 shows the reported seating location for each passenger; the fatally injured passenger was No. 3. The cockpit is to the left in the figure, with the lavatory and aft section of the airplane to the right, annotated as "LAV."

Figure 2: Seating Configuration with passenger seating locations annotated.

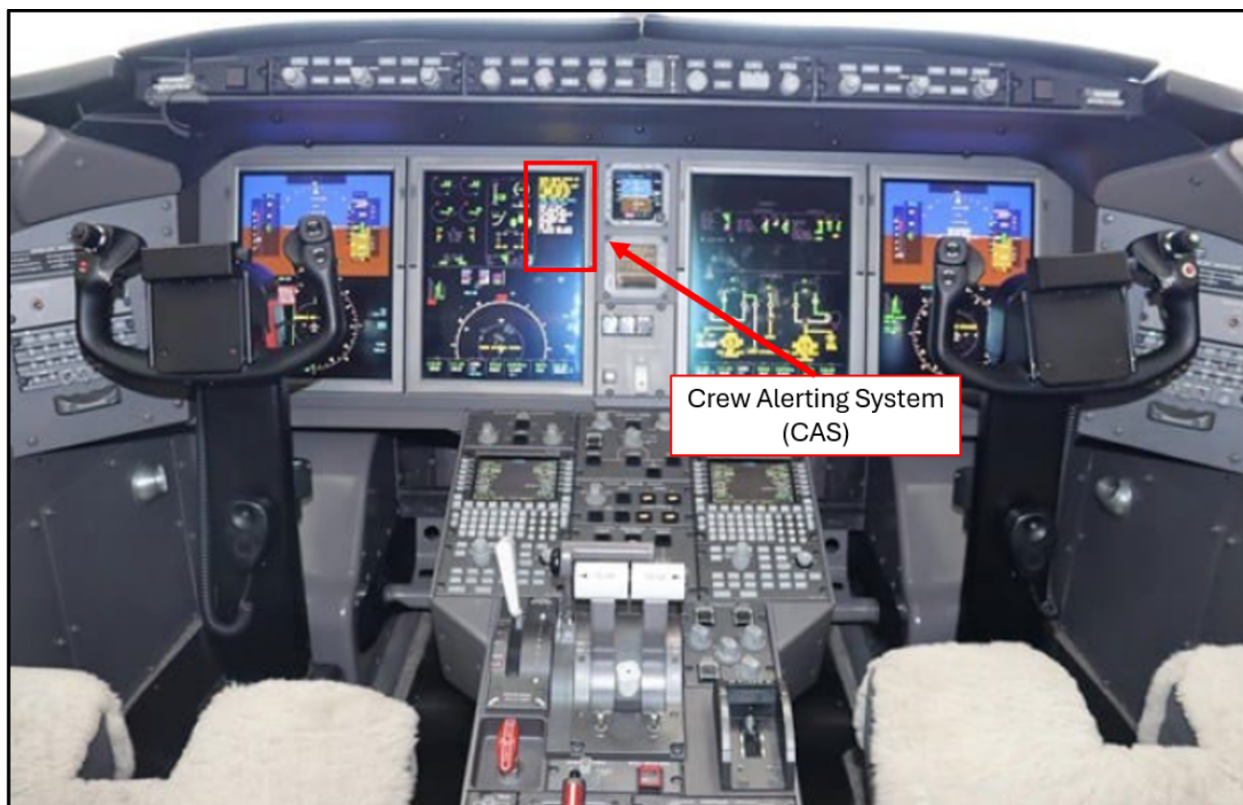
Figure 3: View of the cockpit in the accident airplane with the CAS location annotated (Source of Photo: Aircraft.com)

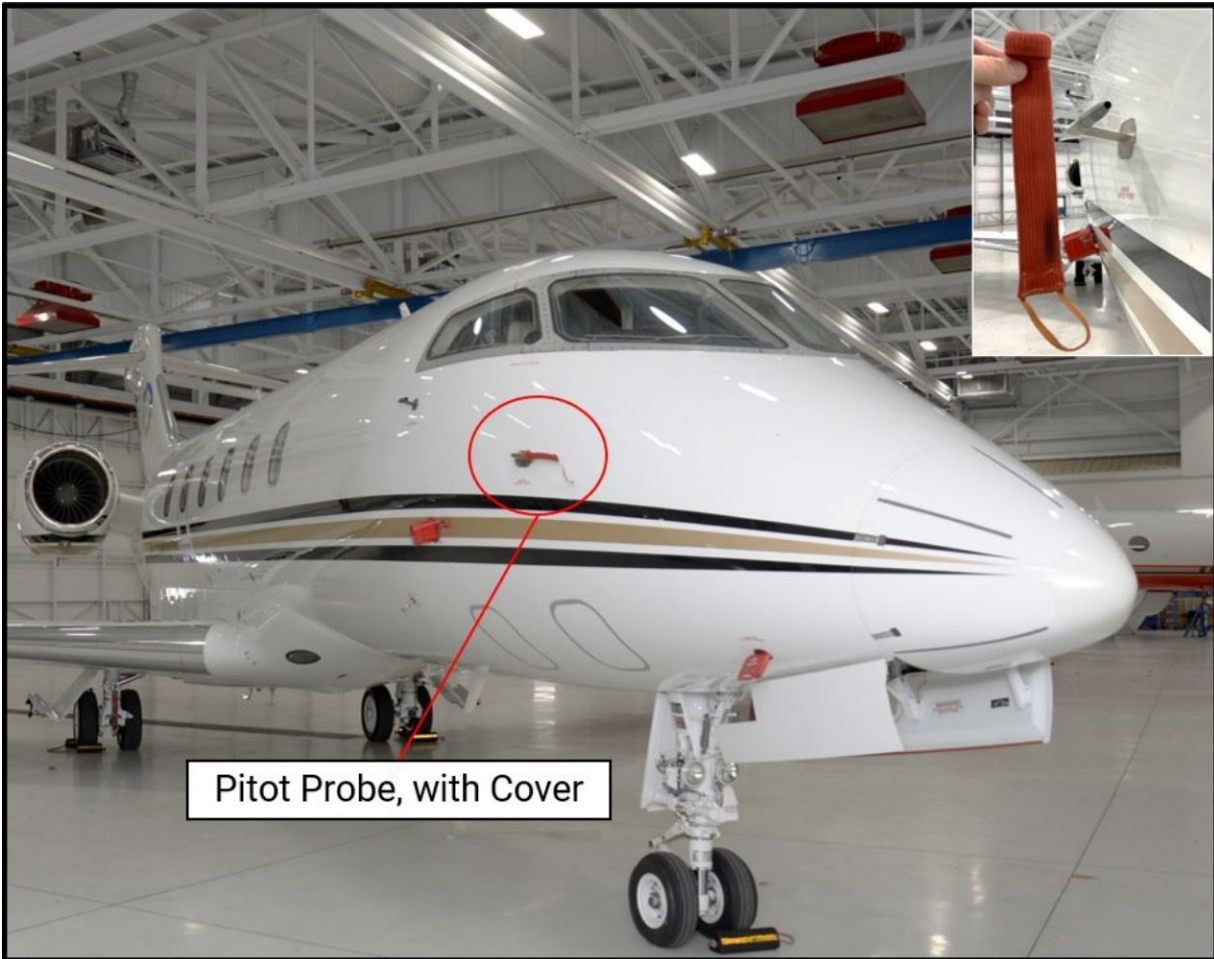
he subsequently observed that the red pitot probe cover remained installed on the right side pitot probe. The SIC removed the cover, did not see any damage to the probe, and returned to the cockpit.

Figure 4 contains photographs that were taken postaccident, which show the right pitot probe cover in place as it would have been on the day of the accident, in addition to a closer view of the red-colored cover.

*Figure 4: View of the right side forward area of the airplane showing the covered pitot probe.*

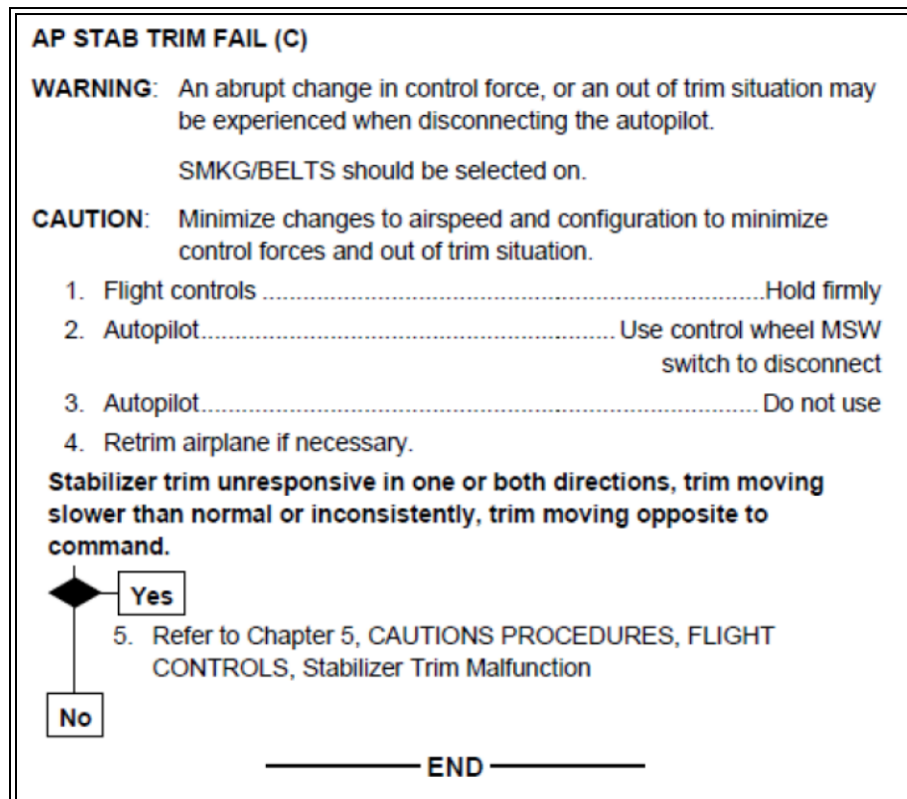
had a temporary revision (TR) in effect for the procedure, which was TR-39-1, dated June 15, 2022 (see Figure 6.) That TR was printed on yellow cardstock and was also located in front of or facing the “AP STAB TRIM FAIL” checklist within the QRH both electronically and in the paper copy, located within the accident airplane, respectively.

Figure 6: Temporary revision for AP STAB TRIM FAIL.

The TR included an additional step noted as item 5 within the checklist and reordered items 3 and 4. The TR also included the addition of “Trim Malfunction procedures” and “STAB TRIM FAULT (A) procedures.”

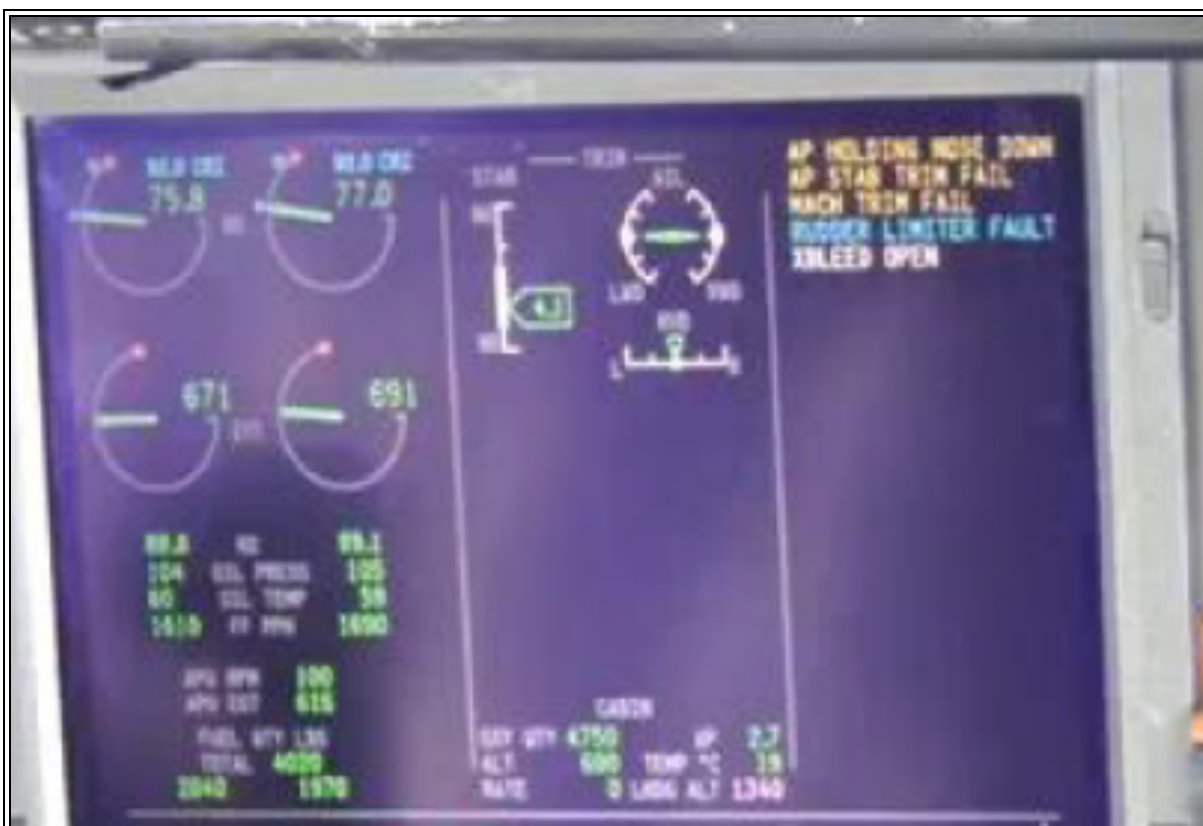
The autopilot was reengaged at 162 kts and 5,750 ft msl. The flight test vehicle was accelerated at a rate of about one knot per second. Upon reaching 182 kts, the "AP HOLDING NOSE DOWN" caution message posted. When speed was reduced below 182 kts, the "AP HOLDING NOSE DOWN" message cleared. The flight test vehicle flight crew subsequently executed the "AP STAB TRIM FAIL" checklist, which included turning the autopilot off, and returned to land without incident. Figure 8 shows the PFD and CAS displaying the series of caution messages observed with the autopilot on and with the airplane having accelerated into an out of trim condition.

Figure 8: View of the flight test vehicle in-flight with the CAS displaying a series of caution messages and advisory messages.
