Phenom 300 N16DF S/N 50500167

Right Engine Model PW535E

S/N PCE-DG0339

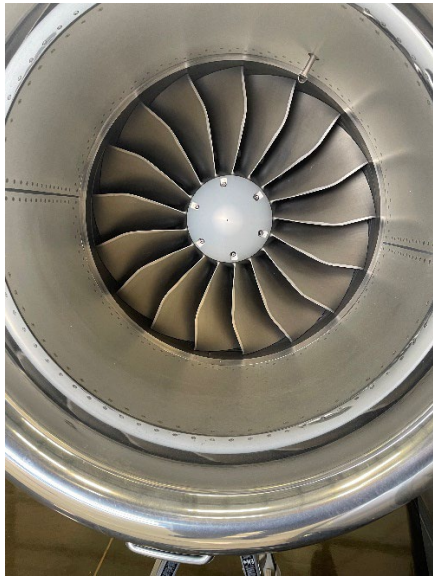
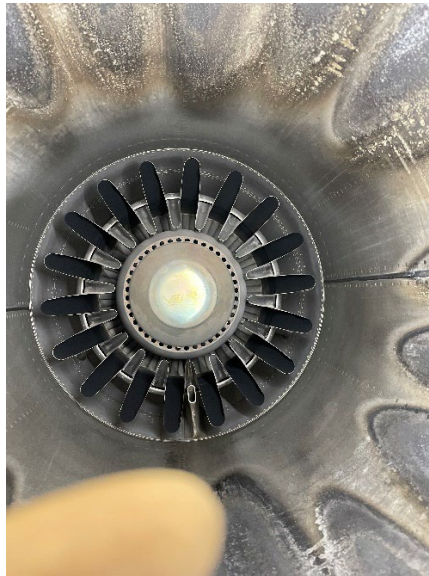
Inspected the nose cone, fan blades, fan case, and fan exit stators. Rotated N1 for unusual noise/vibration. No discrepancy or damage noted.

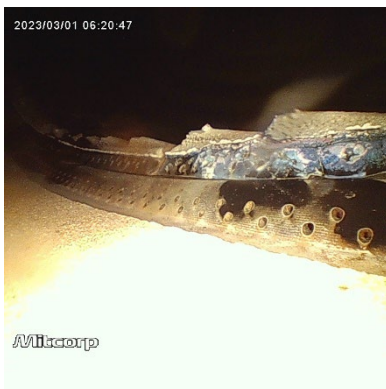
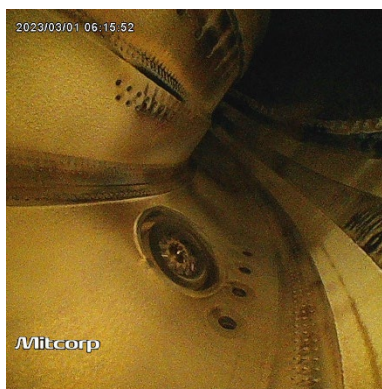
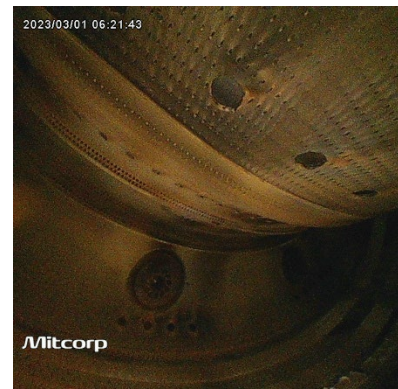
Performed Right Engine Combustion liner borescope for damage and FOD per task 72-00-00-280-808. Some areas starts to oxidize, **recommend to have P&W perform preservation**. No discrepancy noted.

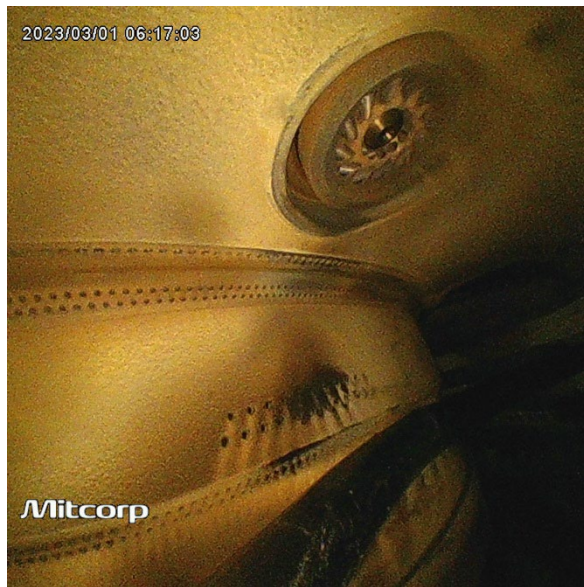
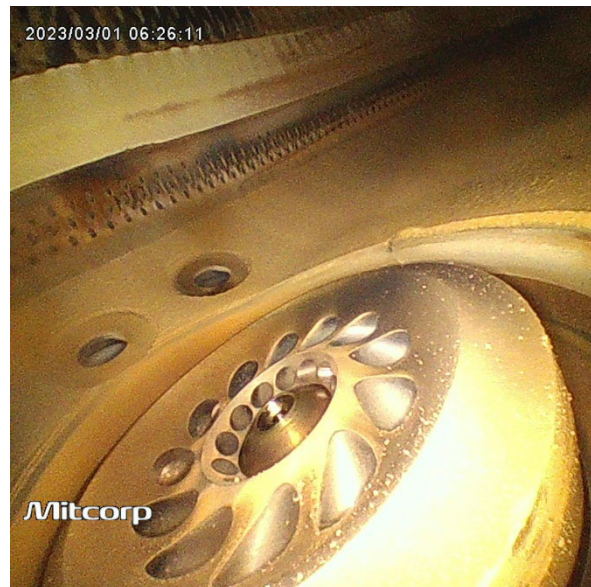
Continuation of photos Right engine combustion liner and fuel nozzles.

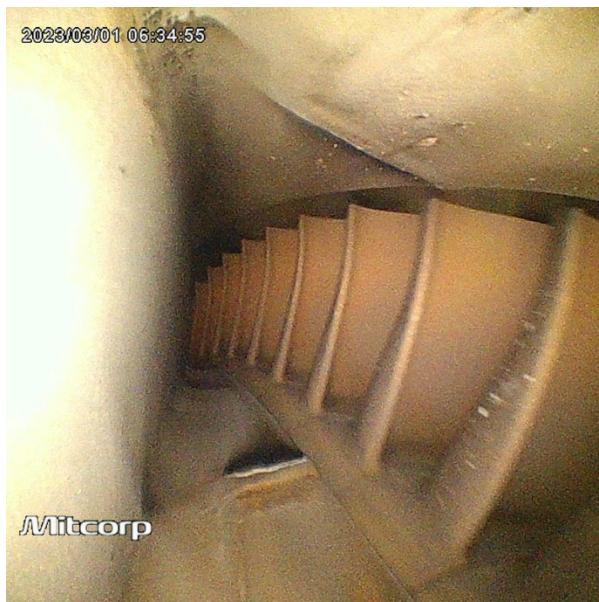
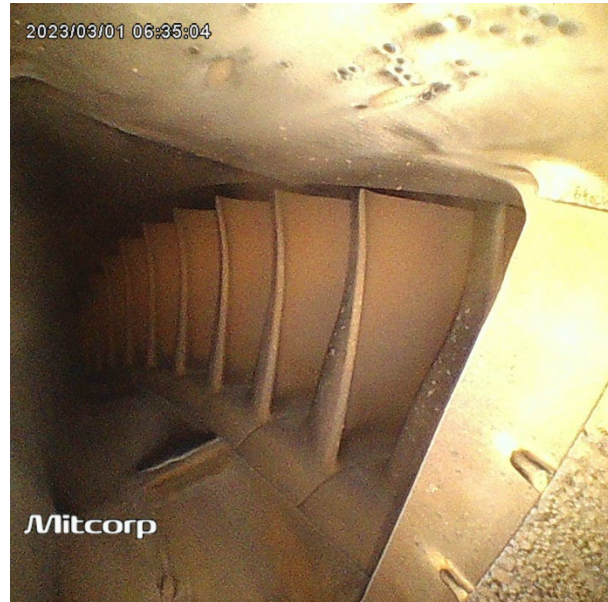
Performed Right engine first stage turbine per task 72-00-00-280-810. No discrepancy noted.

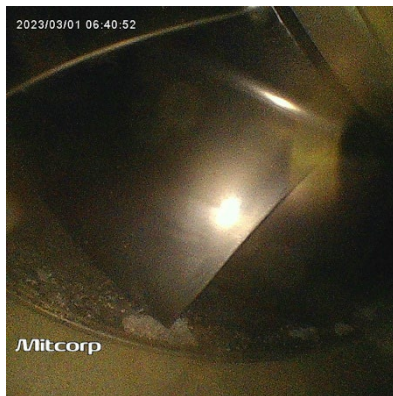
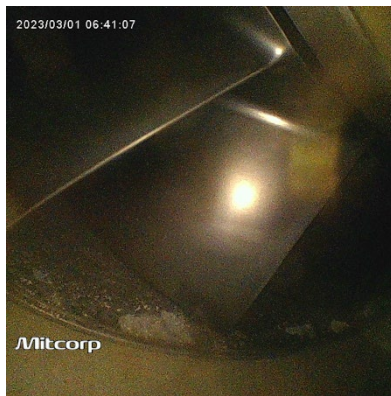
Performed Right Engine Task 72-00-00-280-804 - Borescope Inspection of the First-stage High-compressor Rotor. No discrepancy noted.

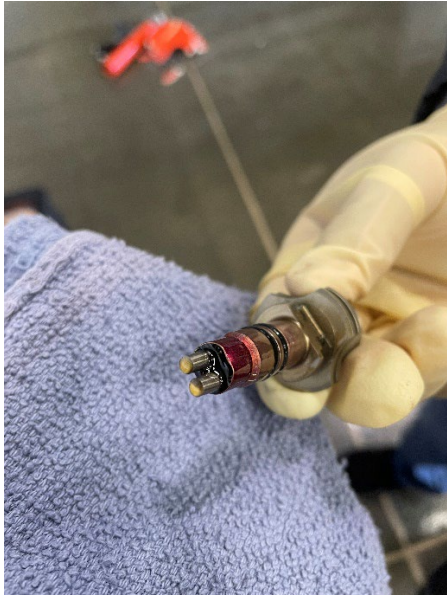
Performed inspection of Right Engine Metal detector per AMM 79-35-00. No discrepancy noted.

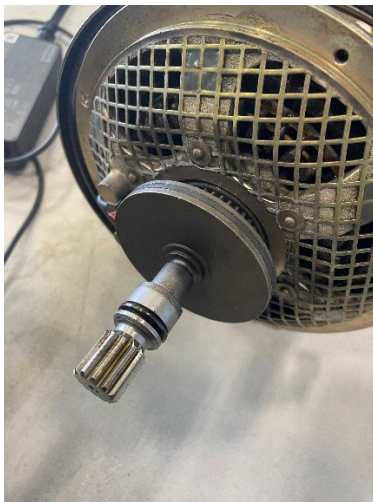
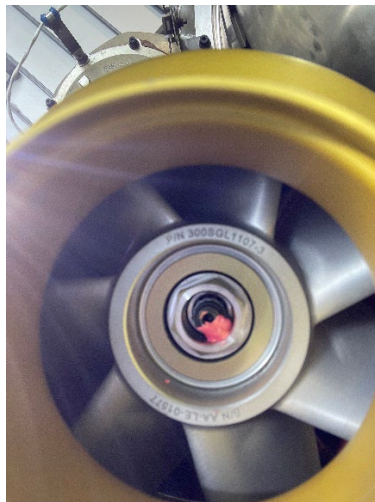
Removed and reinstalled Right Engine Starter Generator. Performed inspection and rotated N2 for unusual noise/ vibration. No discrepancy noted. Ref P300 AMM 24-31-01.
