Phenom 300 N16DF S/N 50500167

Left Engine Model PW535E

S/N PCE-DG0338

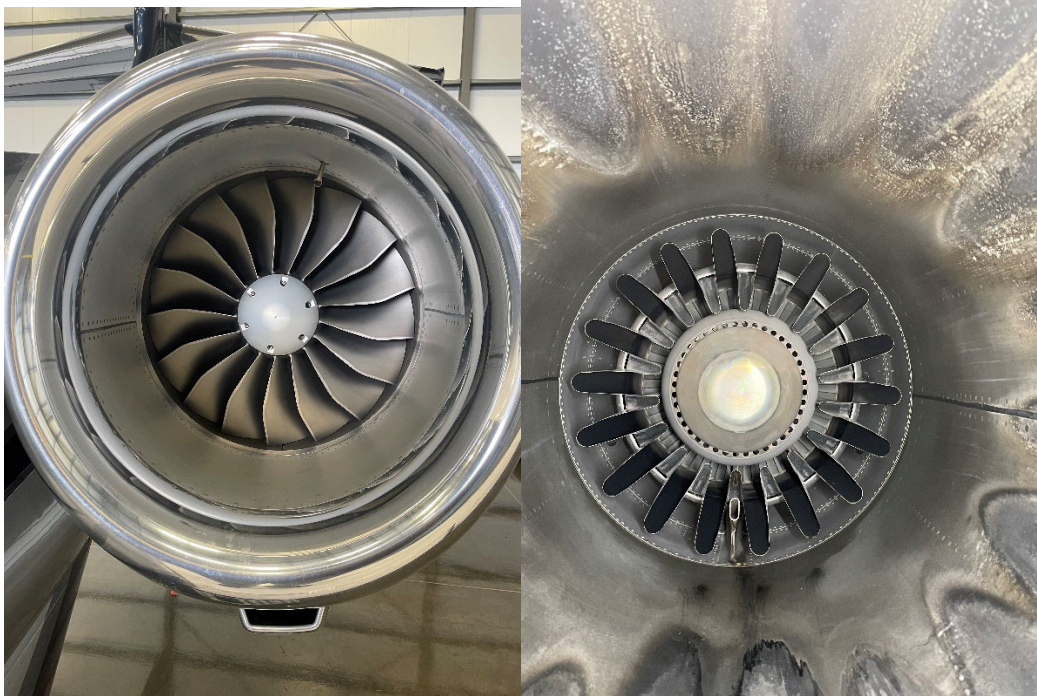
Inspected the nose cone, fan blades, fan case, and fan exit stators. Rotated N1 for unusual noise/vibration. No discrepancy or damage noted.

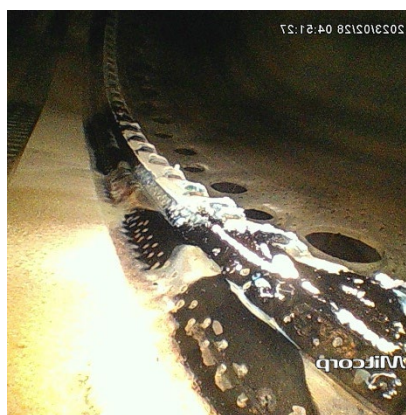
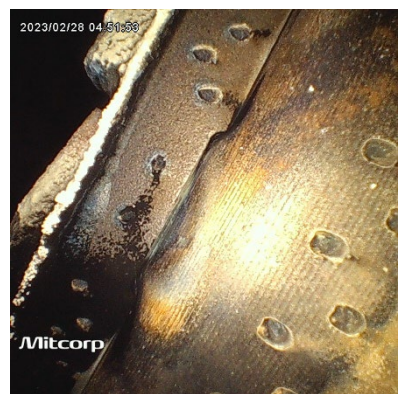
Performed Left Engine Combustion liner borescope for damage and FOD per task 72-00-00-280-808. Some areas starts to oxidize, **recommend to have P&W perform preservation**. No discrepancy noted.

Continuation of photos Left engine combustion liner and first stage turbine vane ring.

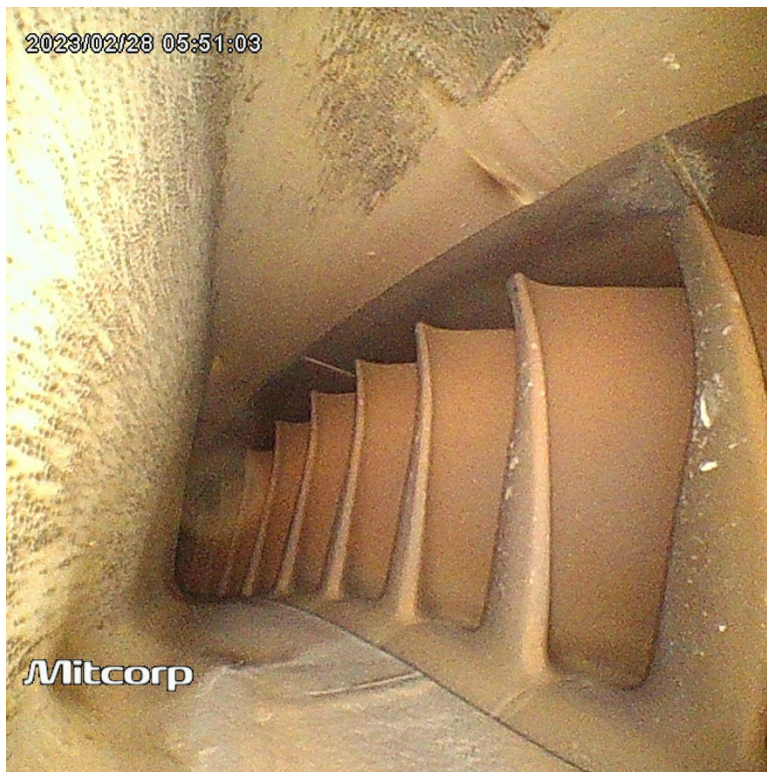
Performed Borescope Left Engine first stage turbine per task 72-00-00-280-810. No discrepancy noted.

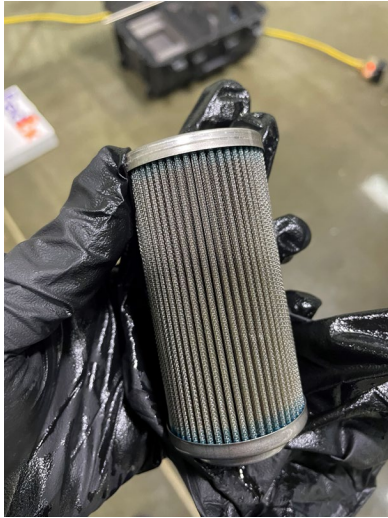
Performed Left engine Fuel and Oil filters detailed inspection. No discrepancy noted. Ref. P300 AMM 73-11-01 (Fuel) and 79-21-00 (Oil).

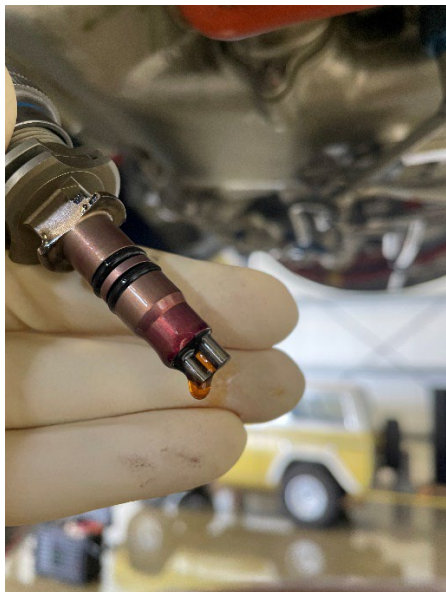
Performed inspection of Left Engine Metal detector per AMM 79-35-00. No discrepancy noted.

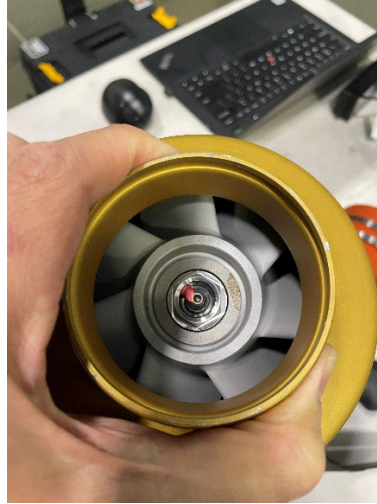
Removed and reinstalled Left Engine Starter Generator. Performed inspection and rotated N2 for unusual noise/ vibration. No discrepancy noted. Ref P300 AMM 24-31-01.
